THE MINING Journal

2 decades later, reclaiming watercourse

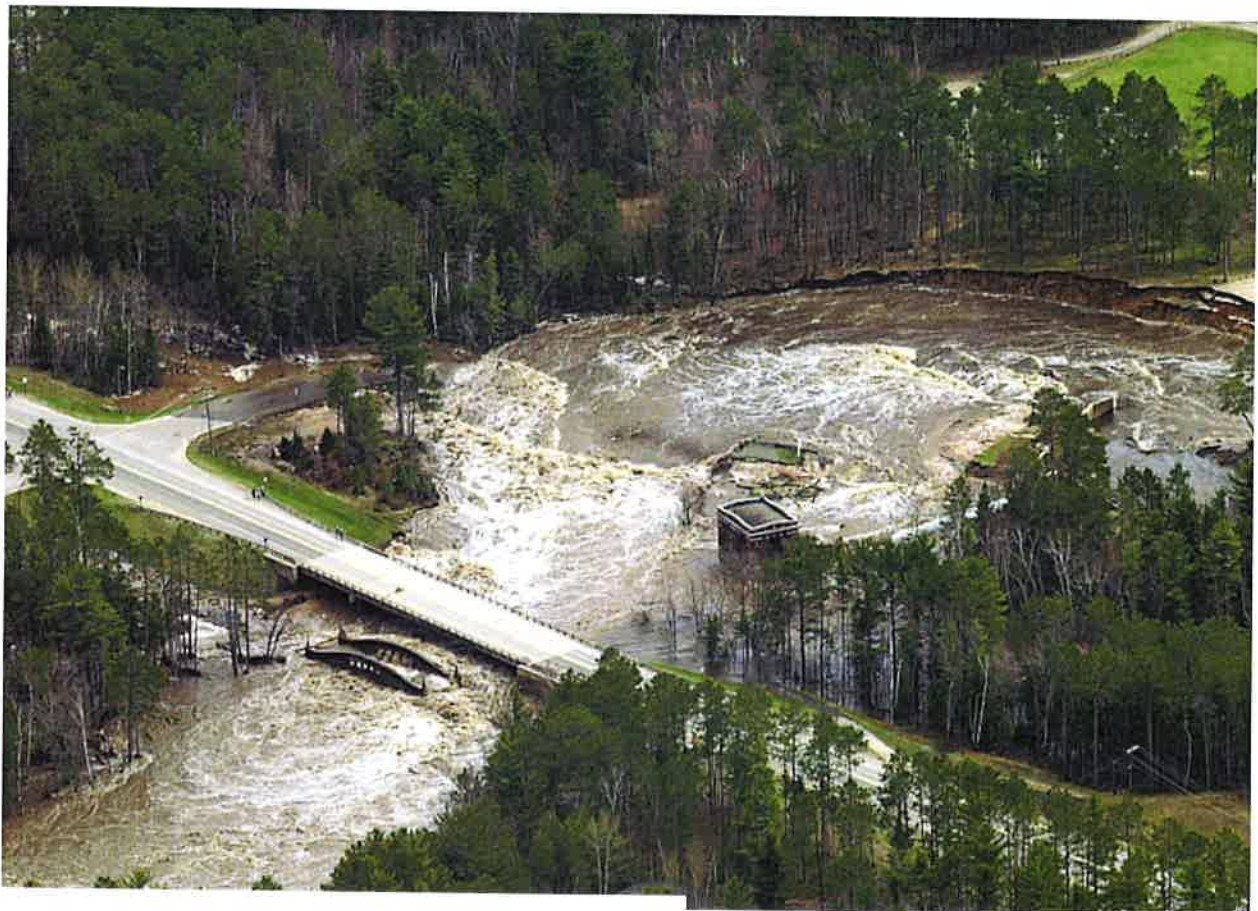
(Dam during the May 2003 Dead River flood.
resources)

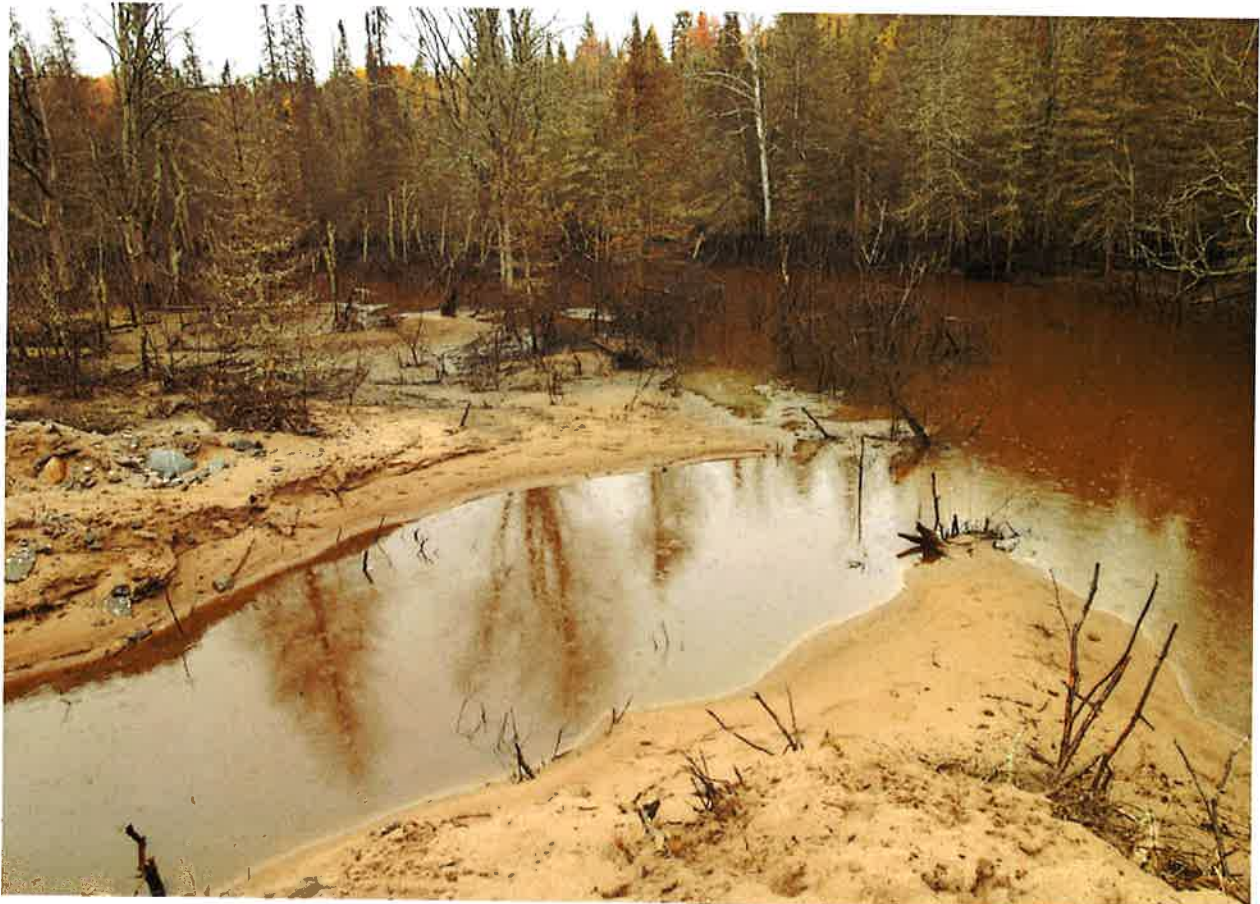
County is seen in this photo. (Photo courtesy of

dam at Silver Lake.

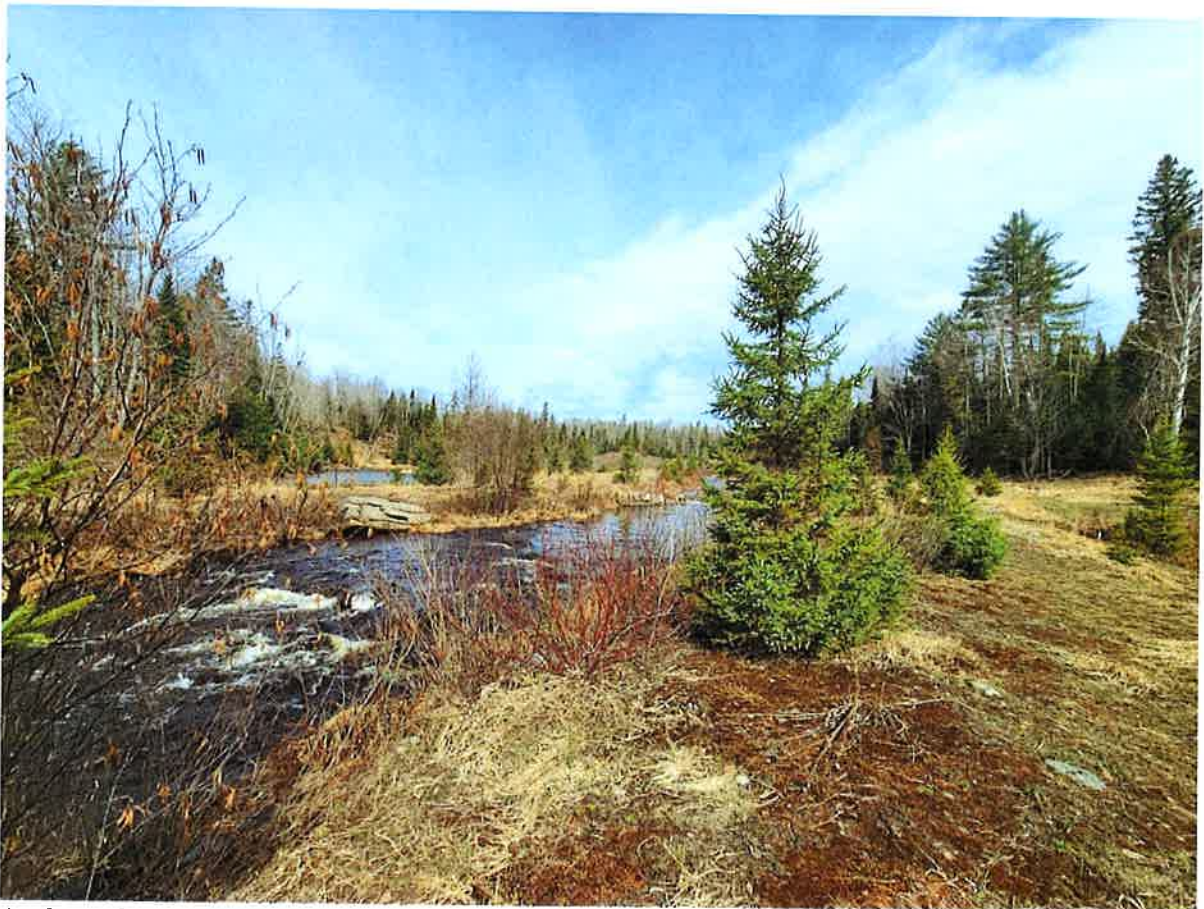
This photo shows the reconstructed Dead River watercourse in 2022. (Photo courtesy of the Michigan Department of Natural Resources)

One of the landmark projects of the restoration efforts was the rebuilding of the Dead River channel from the Silver Lake Basin downstream to Marquette County Road AAO.

An engineering process called *“natural channel design”* was used.

Within the project area, the river was directed in serpentine fashion with large boulders put in the river at certain places to create rapids, pools and habitat for fish. Floodwater catching and recharging wetlands were also constructed along the river to help capture and hold flood water from the river during natural flows and large flood events in the future.
