Dead River Hydroelectric Project

Follow-Up 2016 Hoist Erosion Survey and 2017 Silver Lake Storage Basin Erosion Survey

APPENDIX A – 2015, 2016 and 2017 Dead River Storage Basin
Photographs

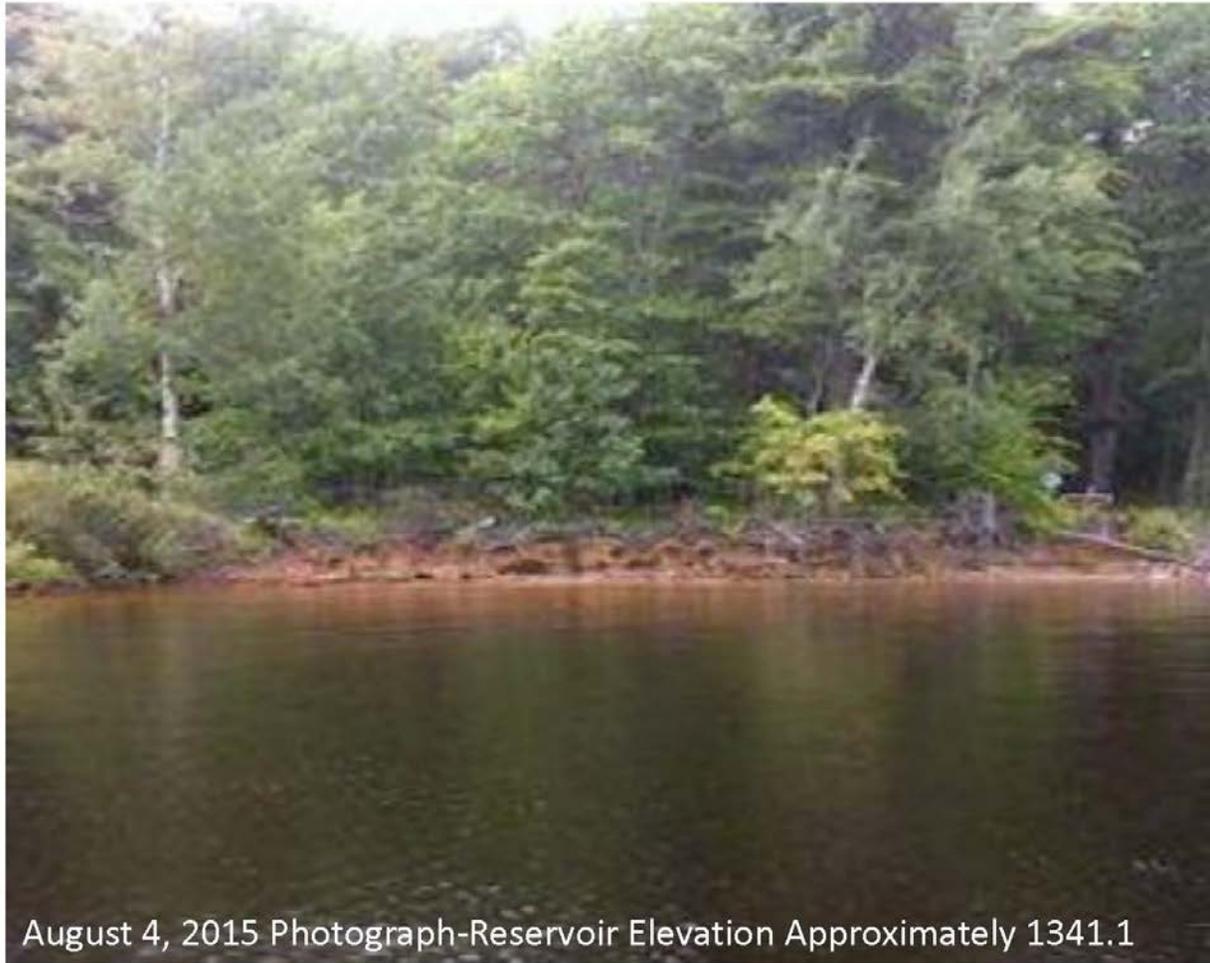
Site 2015 46°33'54" 87°33'54"

August 4, 2015 Photograph-Reservoir Elevation Approximately 1341.1

In viewing the photographs, the erosion has increased since 2015 as the woody vegetation/debris on the shoreline begins to slow the recession of the bank. At this time, any proposed stabilization measures which would most-likely involve toe protection with woody debris, would create more-intrusion than what is currently occurring. Therefore, UPPCO proposes to visit the site again in 2020 as part of the 5-year shoreline survey requirement of the Approved Shoreline and Bank Erosion Control Plan under Article 401 (approved plan). At that time, UPPCO will determine if active erosion is still occurring, and if so, make further recommendations.

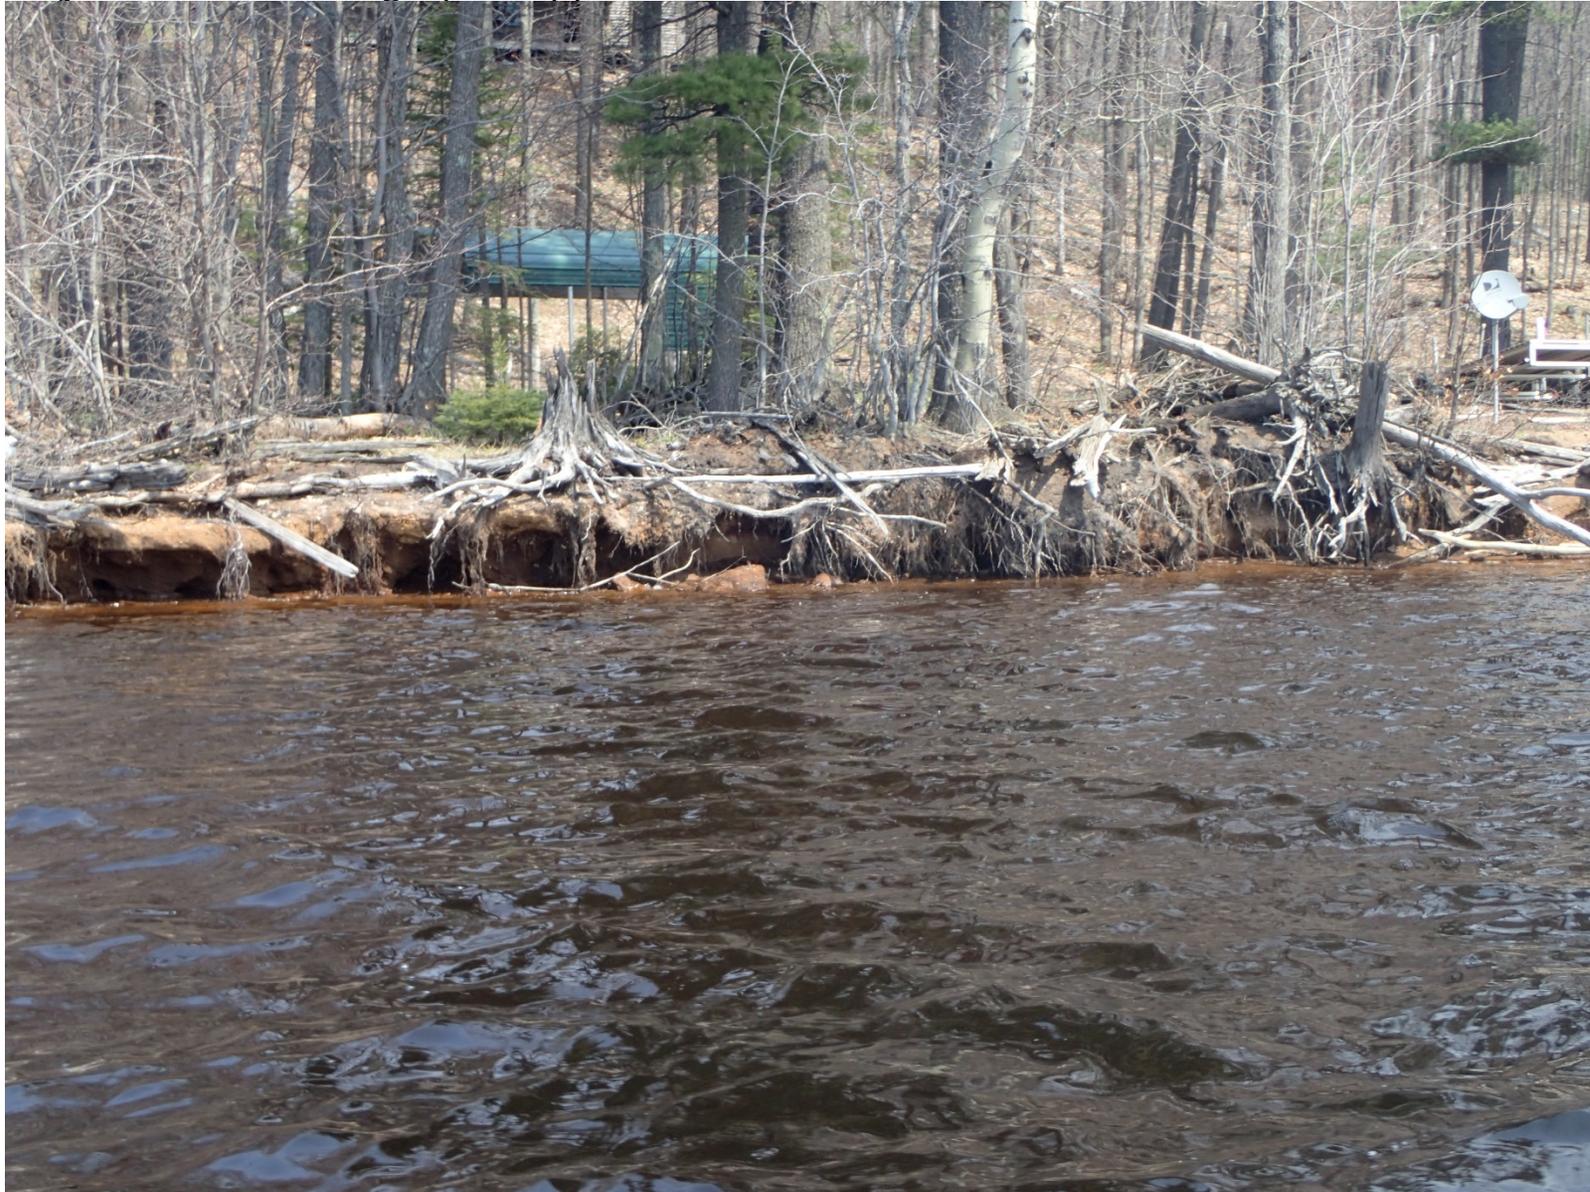
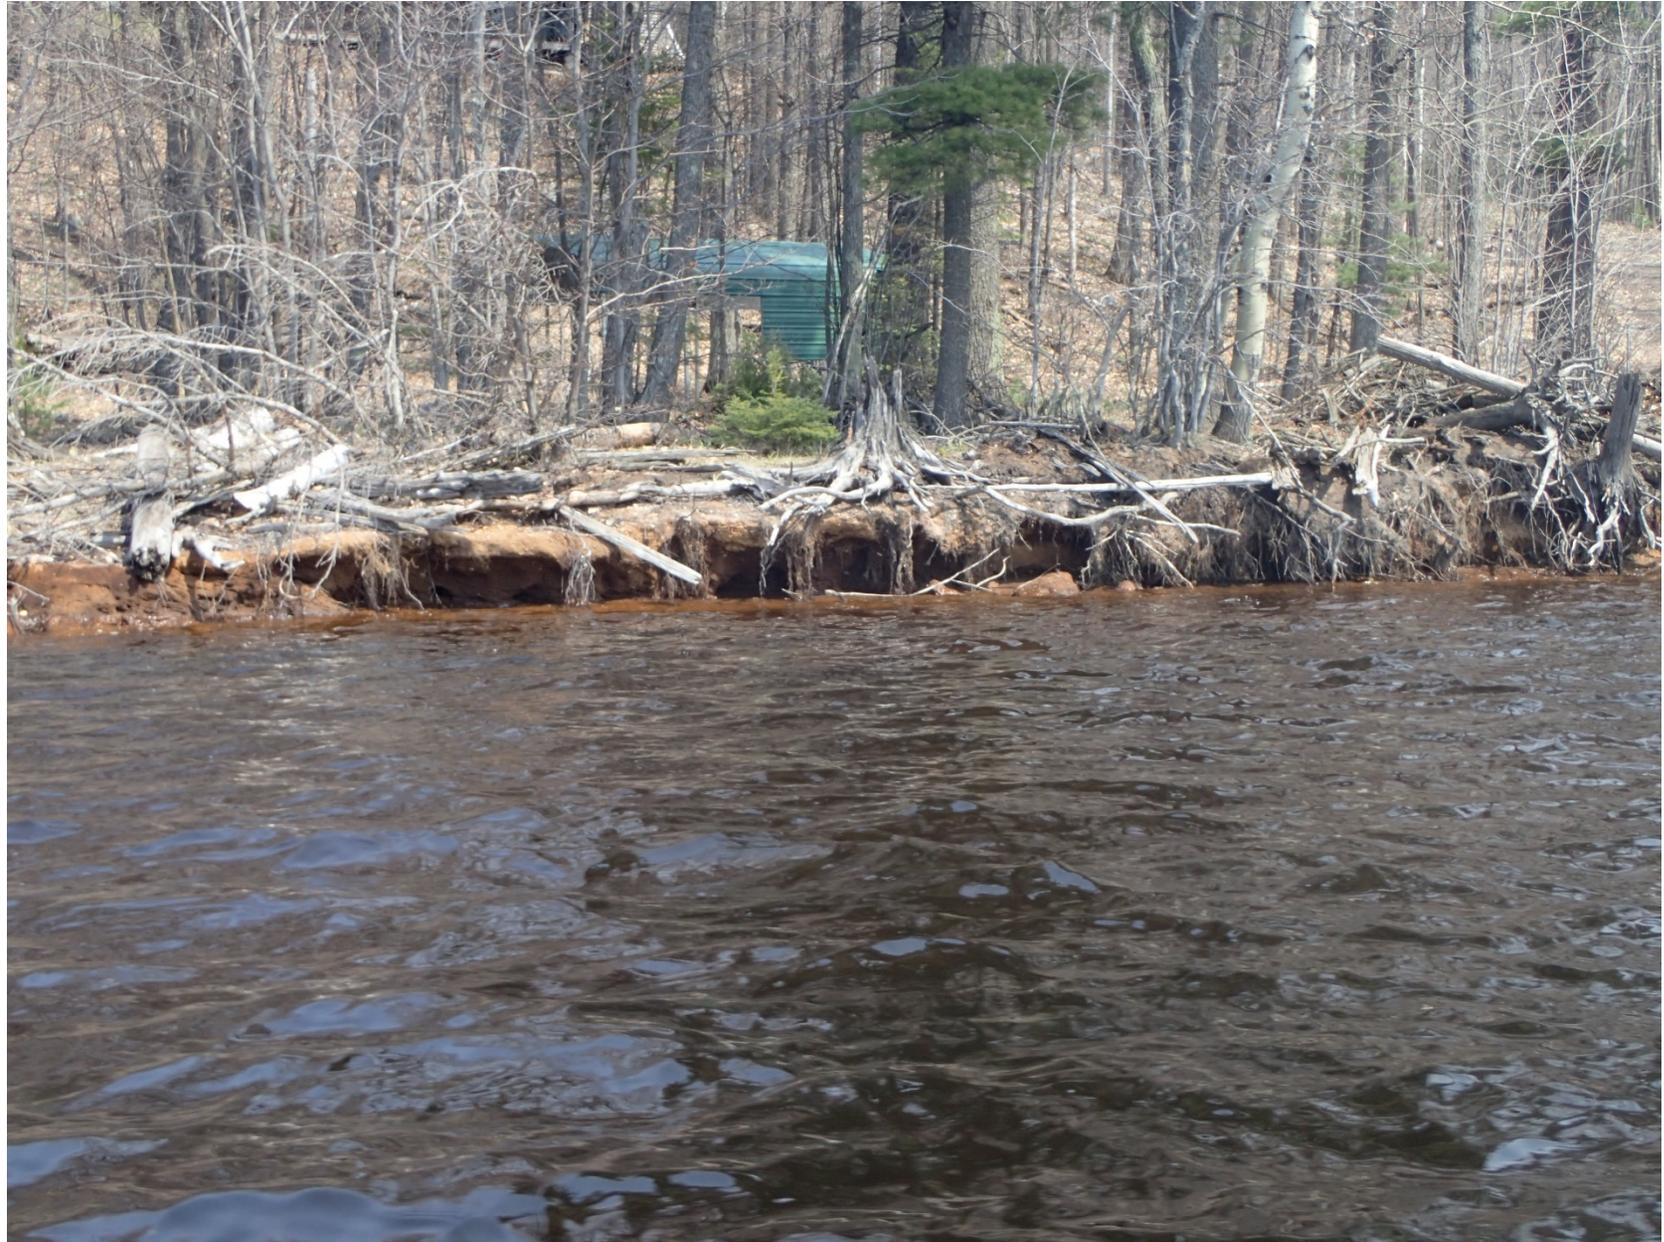
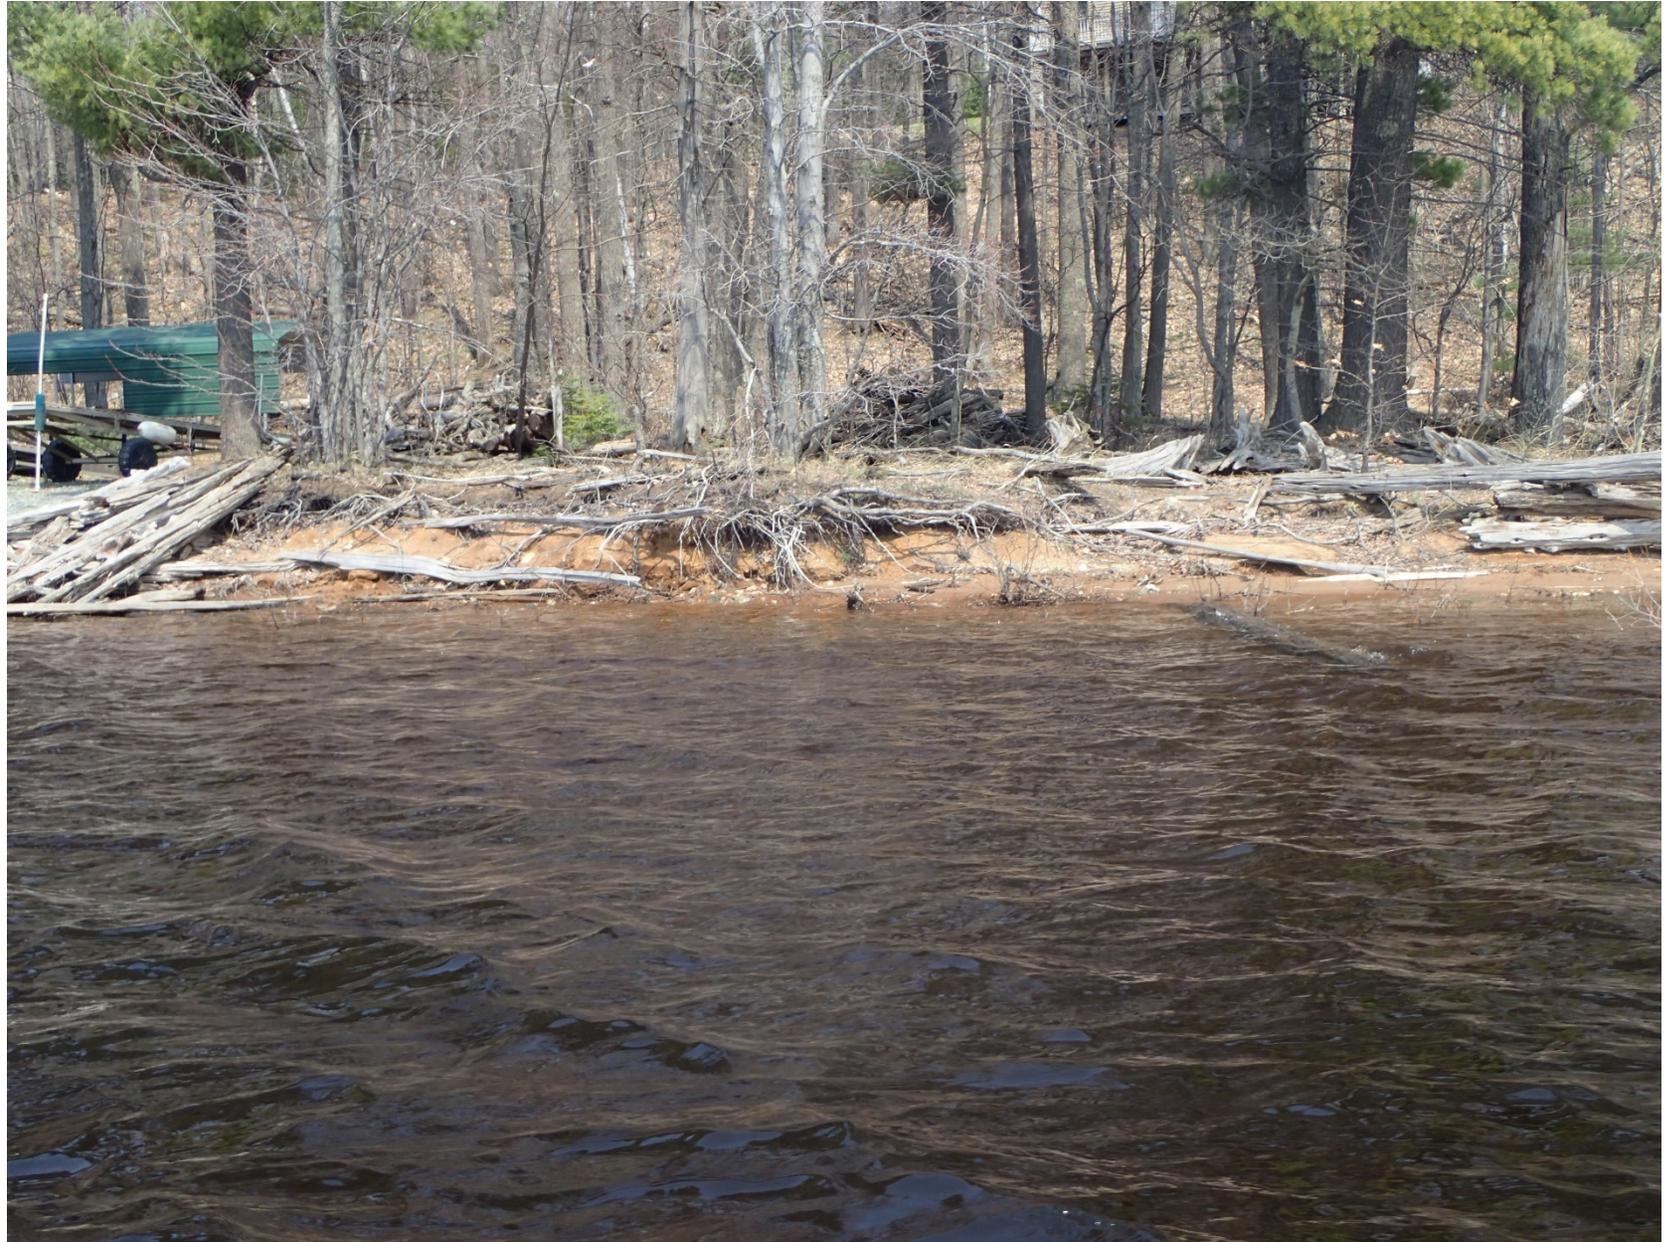
May 10, 2016 Photographs-Approximate Elevation 1342.3 feet NGVD

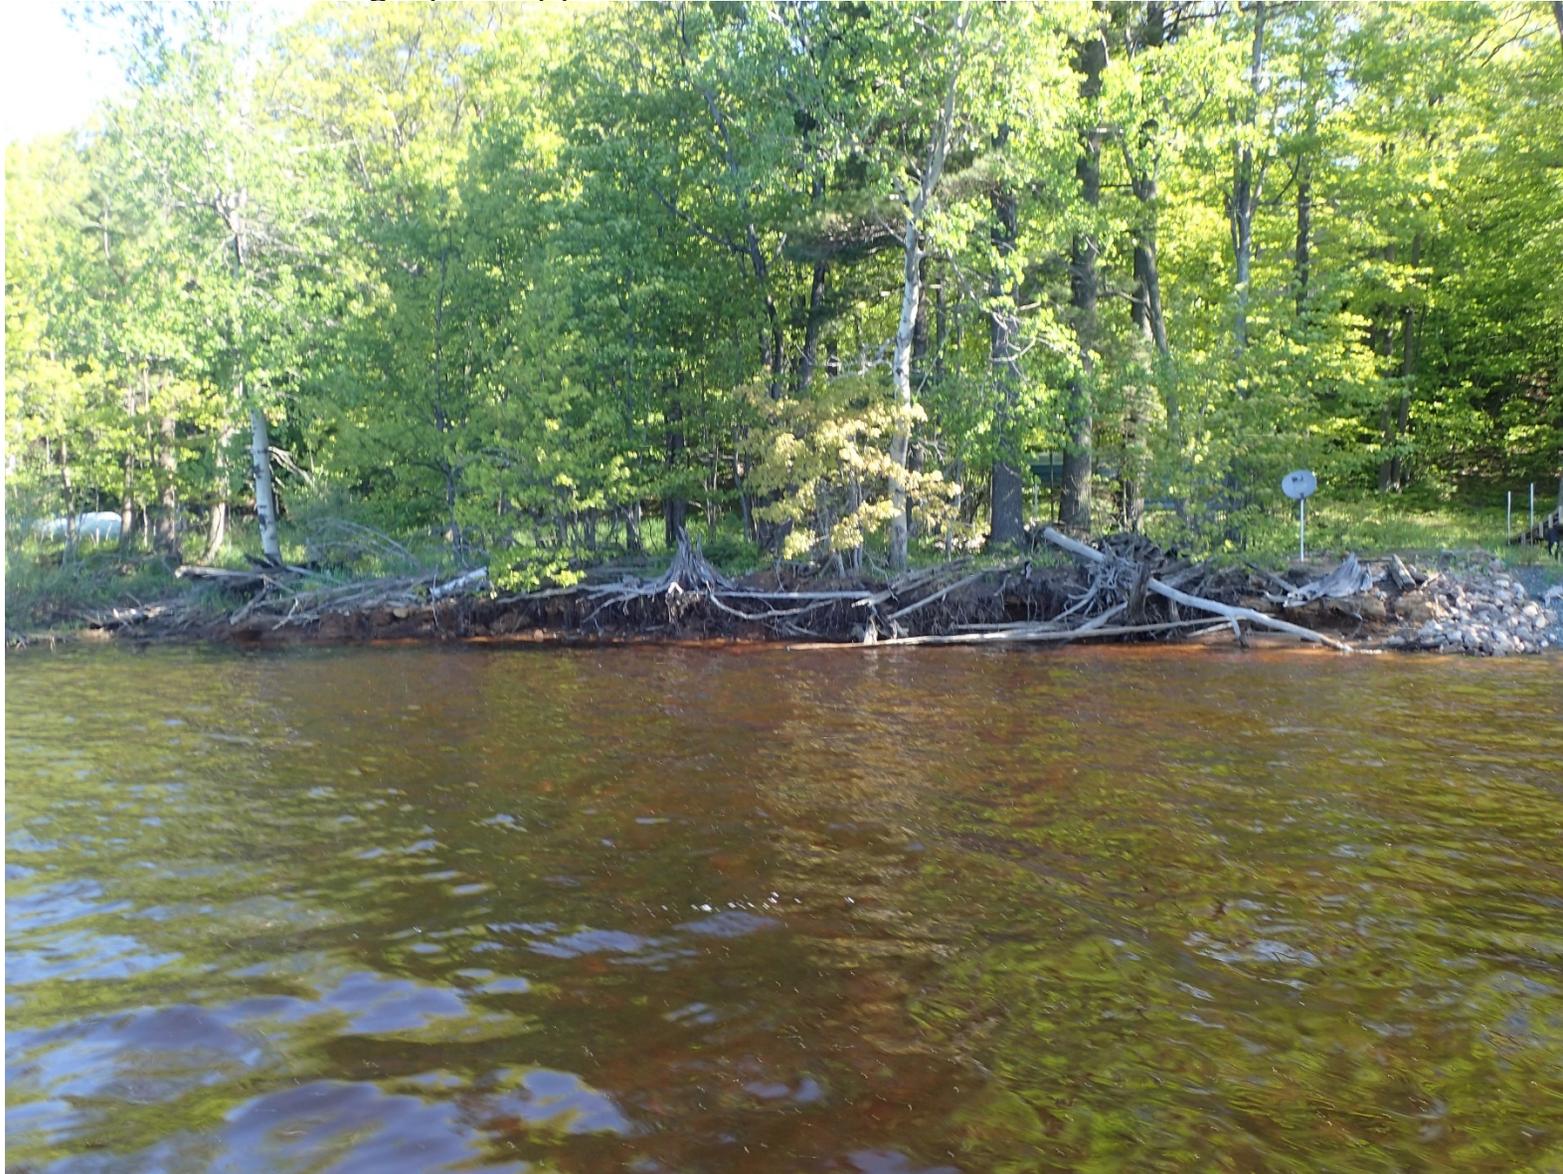
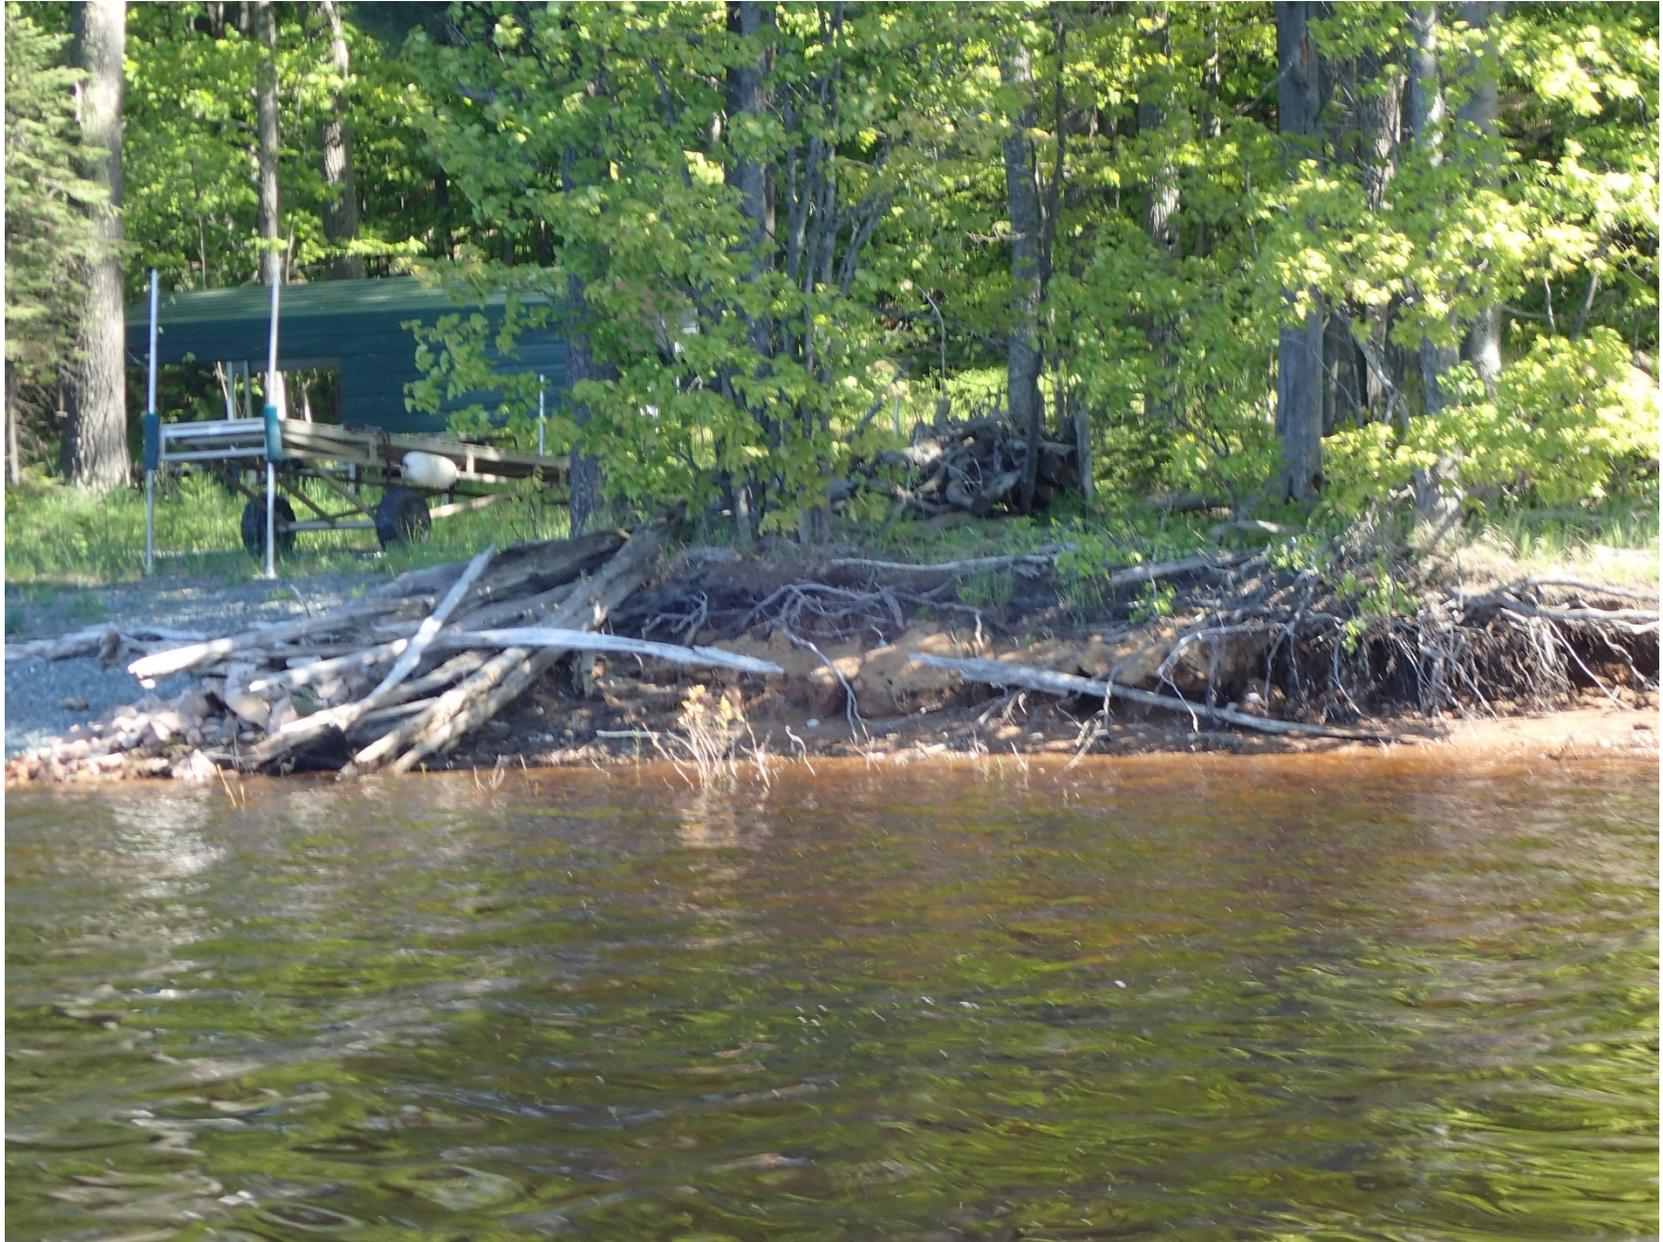
June 7, 2017 Photographs-Approximate Elevation 1342.7 feet NGVD

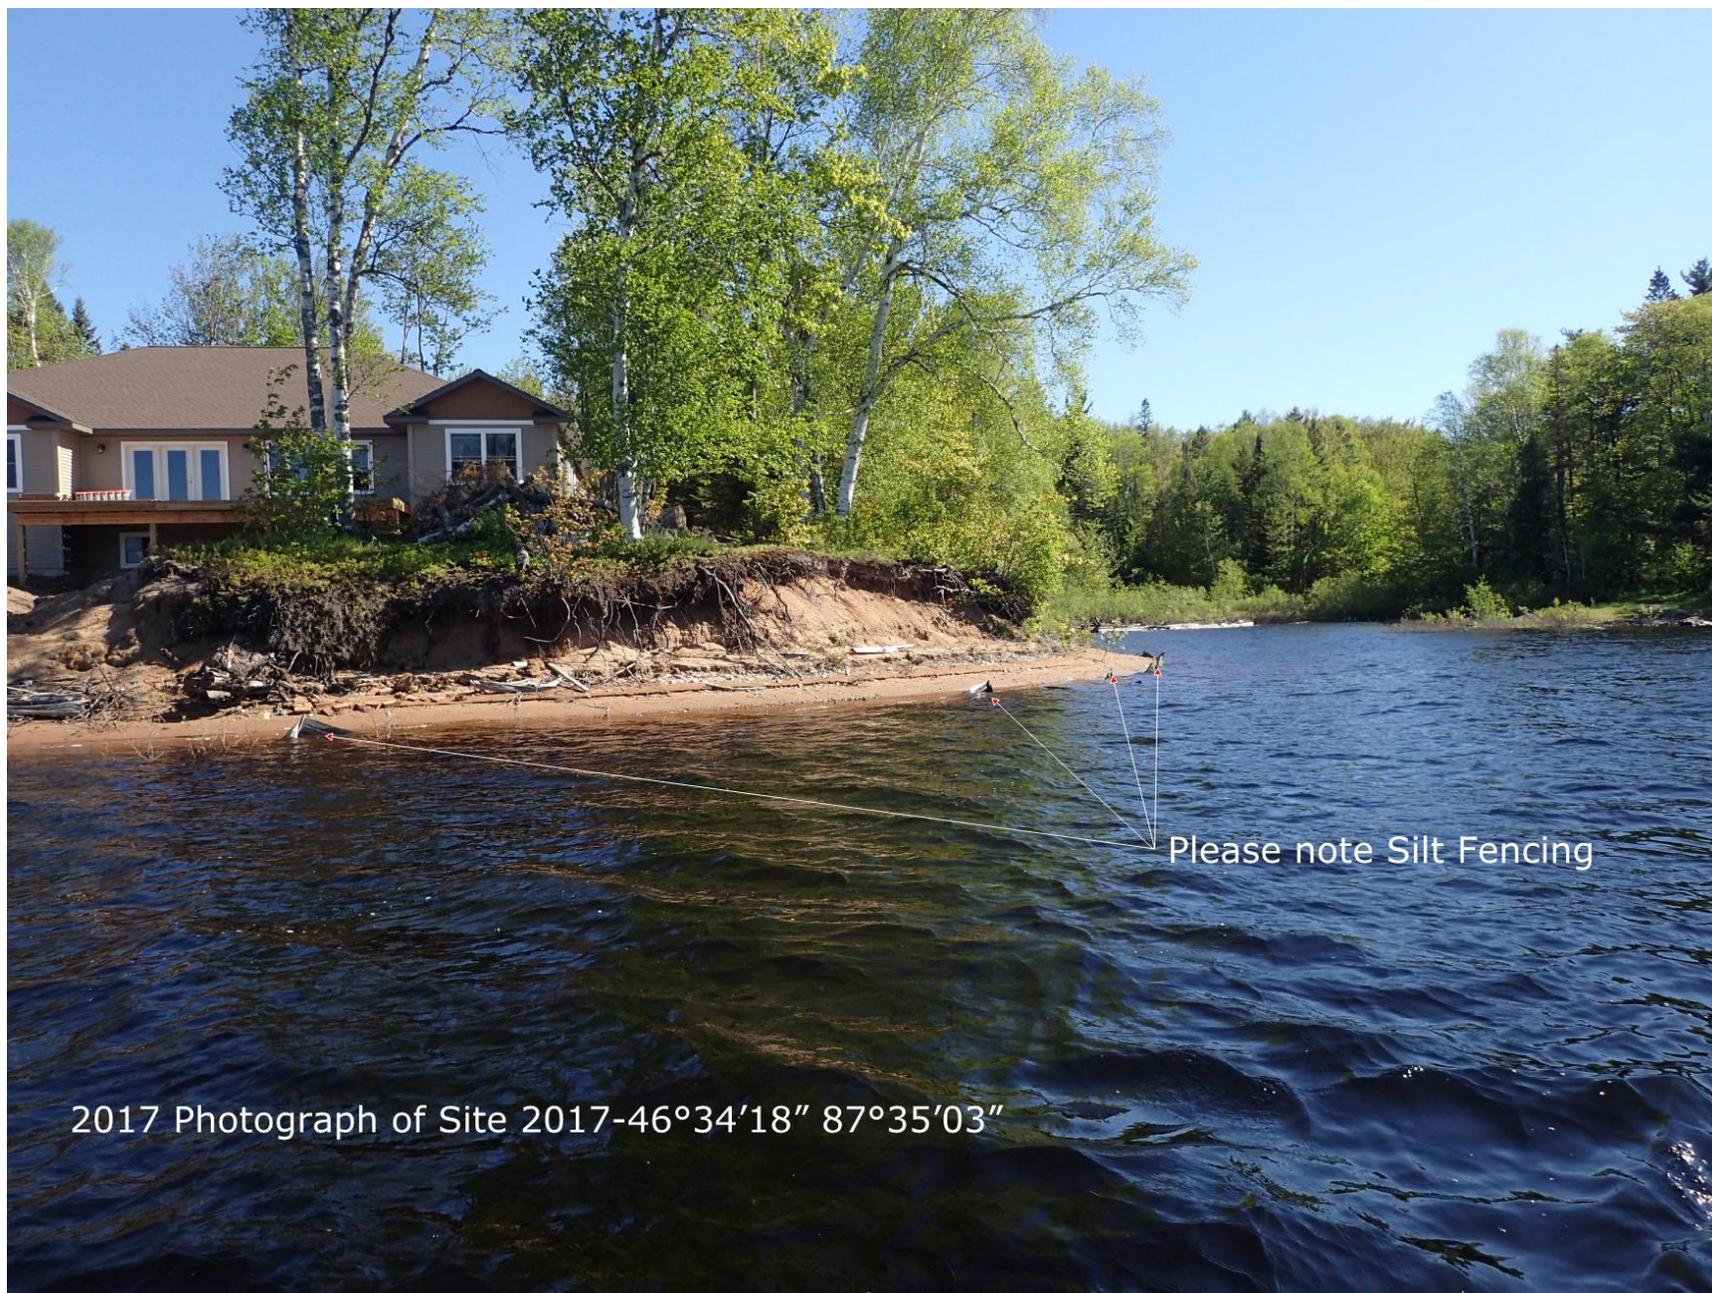
2017 Photograph of Site 2017-46°34'18'' 87°35'03''

Separate from the required re-survey of the one erosion area on the north-east side of the Basin (Site 2017 46°34'18" 87°35'03"), UPPCO also observed one area that is actively eroding on the 2017 volunteer review of the 2015 erosion site (See Appendix B). Since this site is being reported by UPPCO separate from the formal five-year reporting protocol, no determination of cause, severity, estimated size, and approximate soil type have been made.³ This site will be visited again in 2020 as part of the 5-year shoreline survey requirement of the approved plan. At that

Please note Silt Fencing

time, UPPCO will provide the required information of the five-year survey and determine if active erosion is recurring, and if so, make further recommendations for this site. A review in 2020 is reasonable because of the recent construction activity of the landowner and the unstable nature of the construction area surrounding the home.⁴

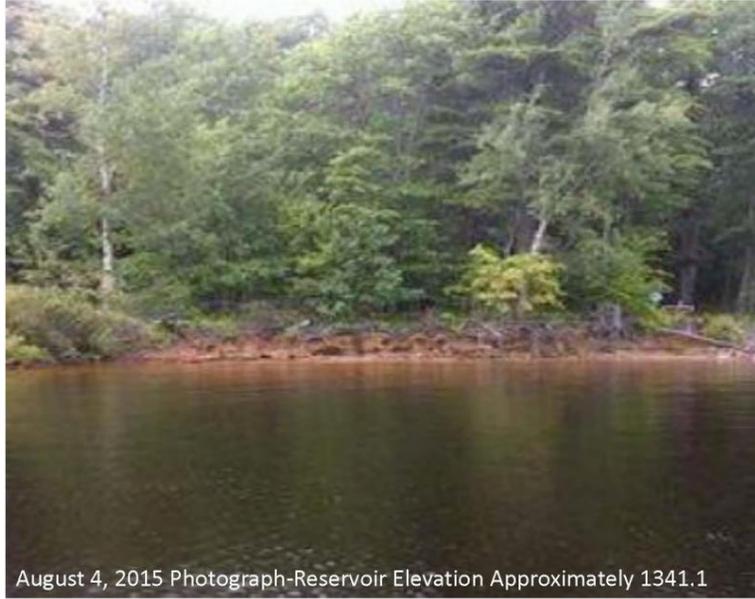
August 4, 2015 Photograph-Reservoir Elevation Approximately 1341.1

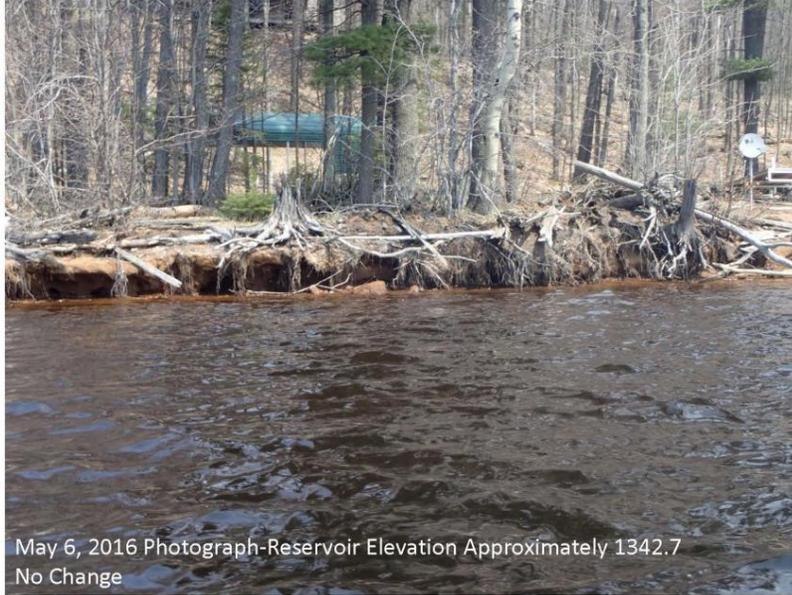
May 6, 2016 Photograph-Reservoir Elevation Approximately 1342.7
No Change

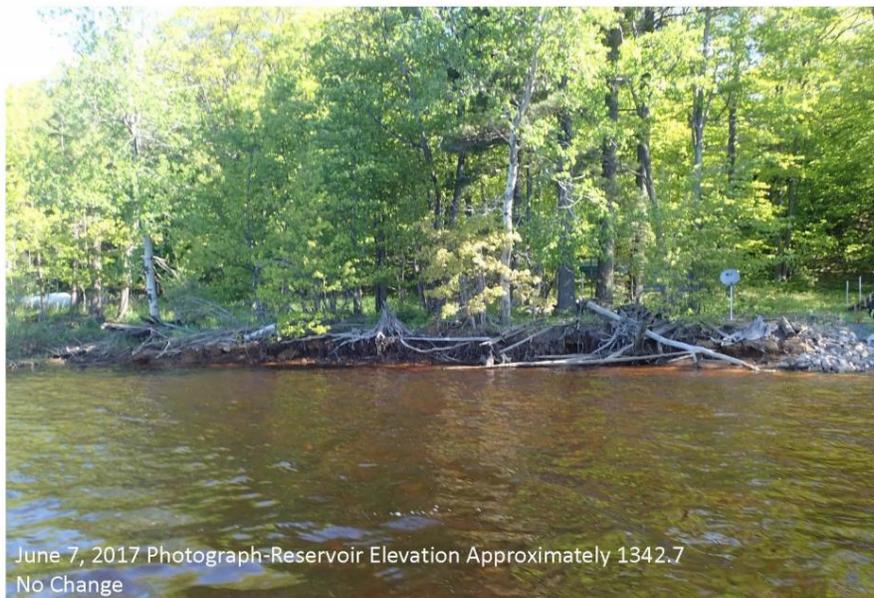
June 7, 2017 Photograph-Reservoir Elevation Approximately 1342.7
No Change

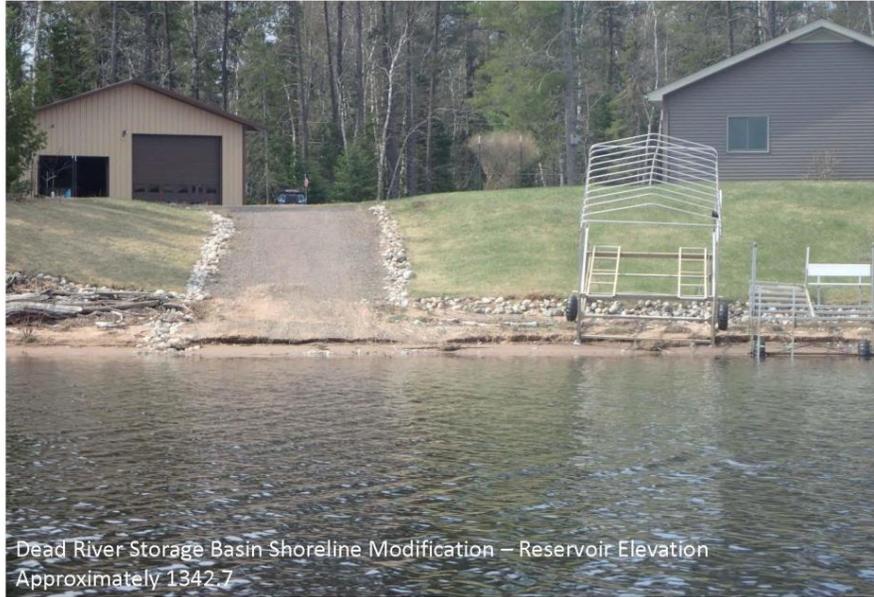
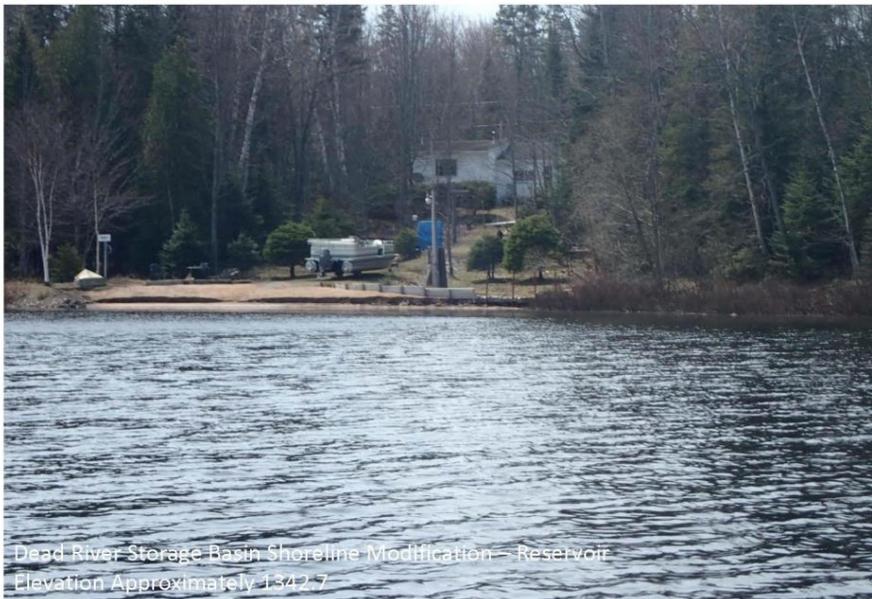
Dead River Storage Basin Shoreline Modification - Reservoir
Elevation Approximately 1342.7

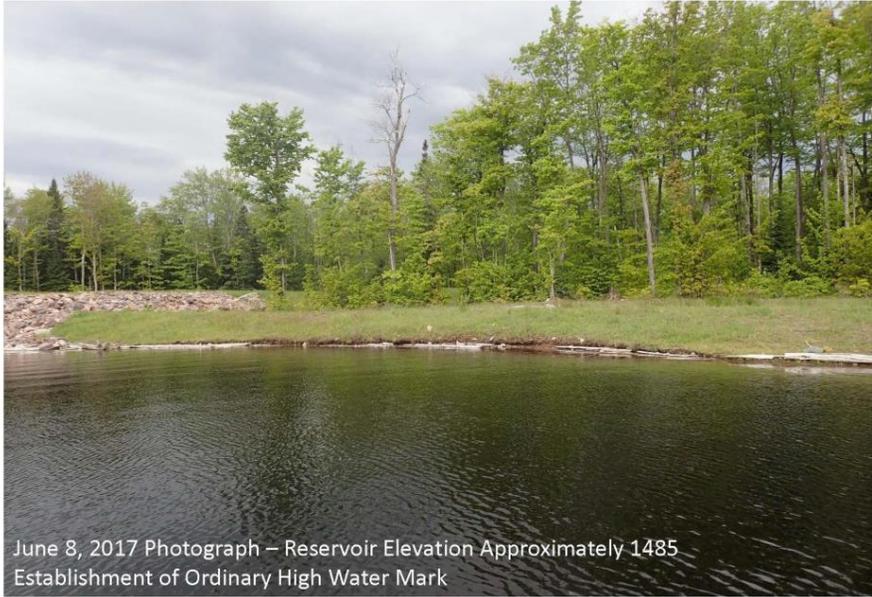
June 8, 2017 Photograph – Reservoir Elevation Approximately 1485
Establishment of Ordinary High Water Mark

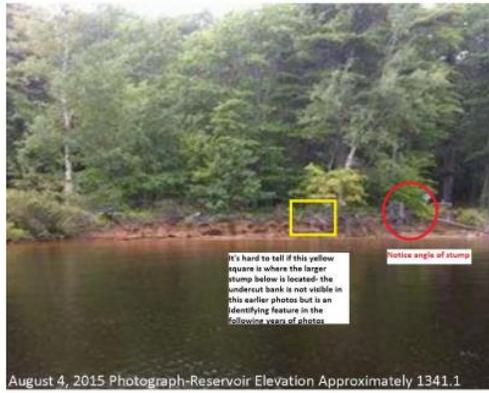
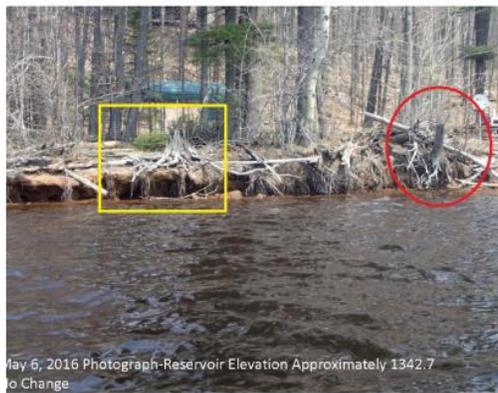
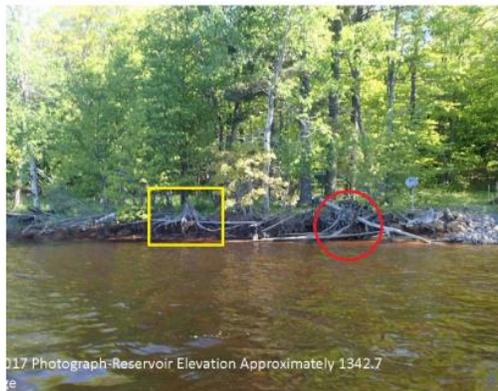
- UPPCO has provided limited evidence to refute the original identification that the site was potentially caused by project operation.
- UPPCO's photos do not support their conclusion that the erosion has not accelerated and that the woody debris on the shoreline means the bank is not receding.

Panel A: photos from UPPCO's Appendix A with areas in yellow to highlight soil loss and red to document large woody debris falling into reservoir, potentially due to erosion inland.

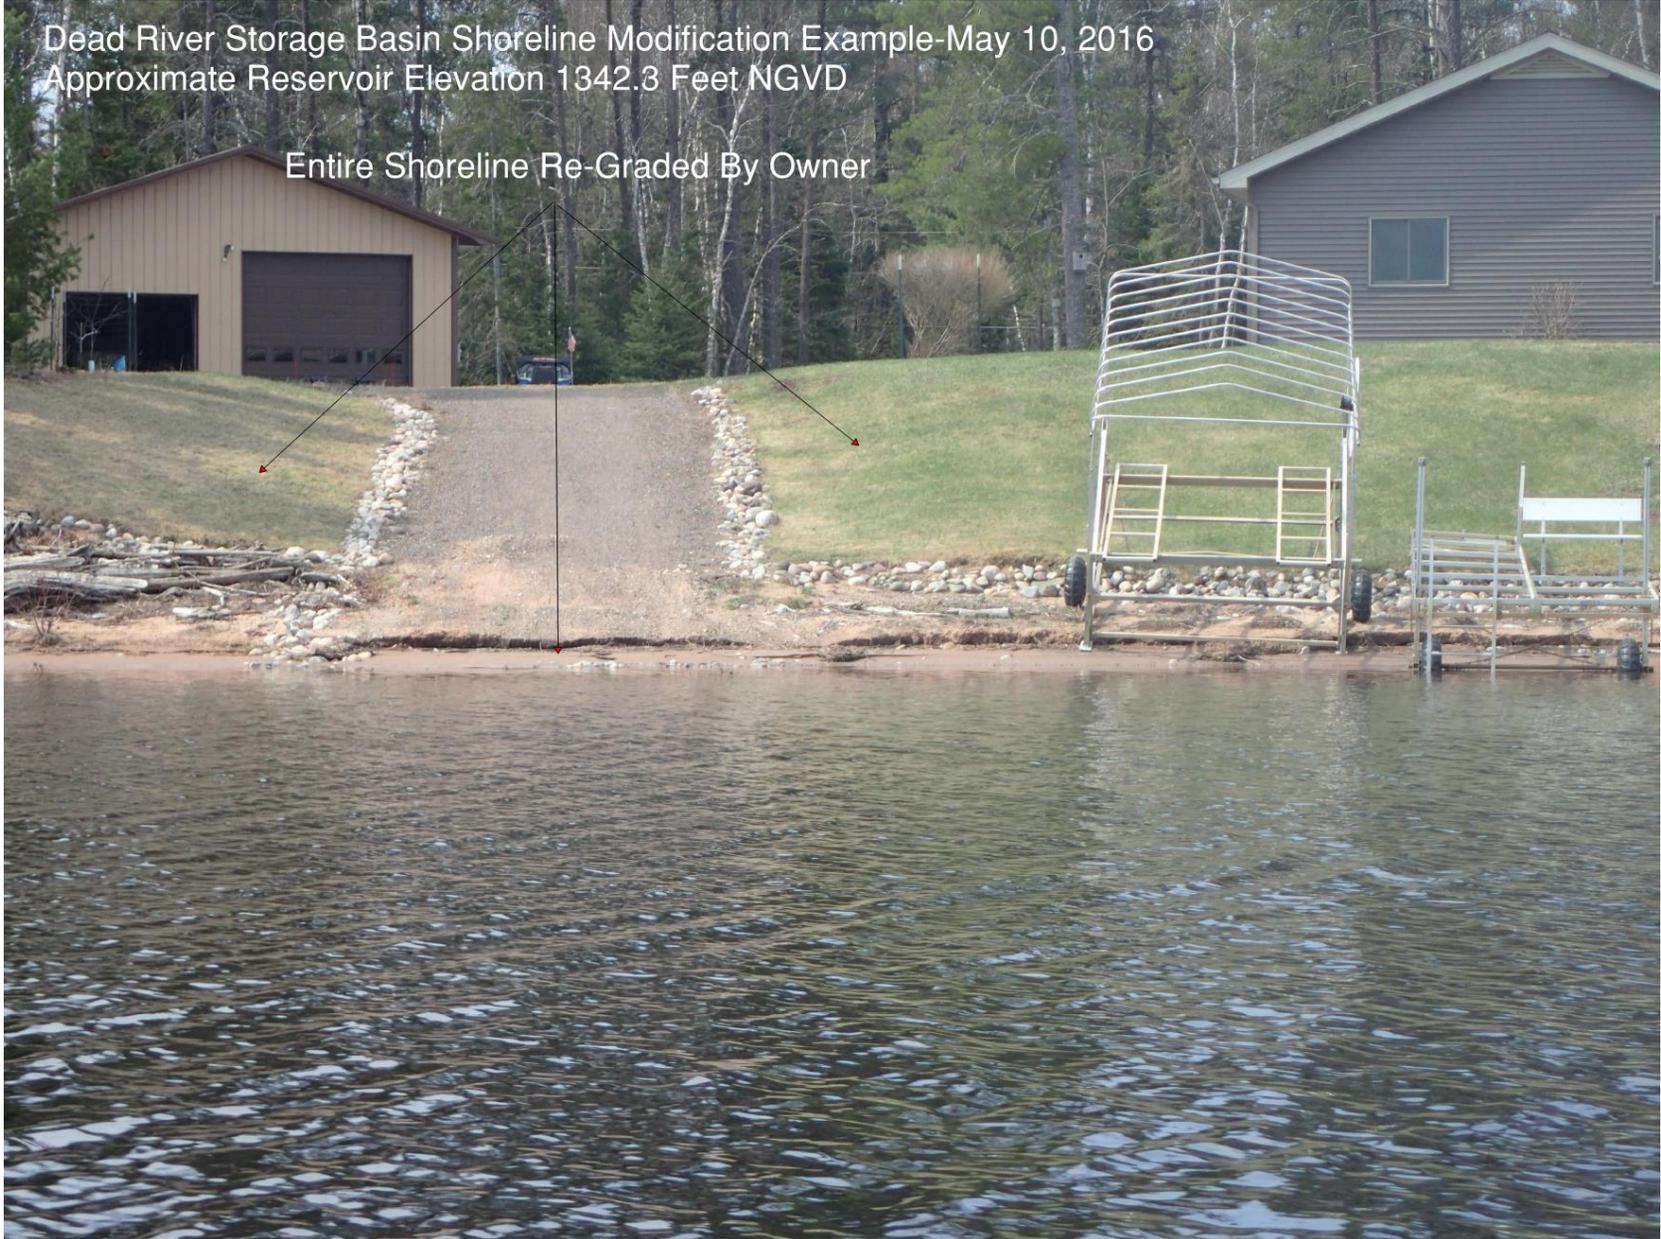
Dead River Storage Basin Shoreline Modification Example-May 10, 2016
Approximate Reservoir Elevation 1342.3 Feet NGVD

Entire Shoreline Re-Graded By Owner

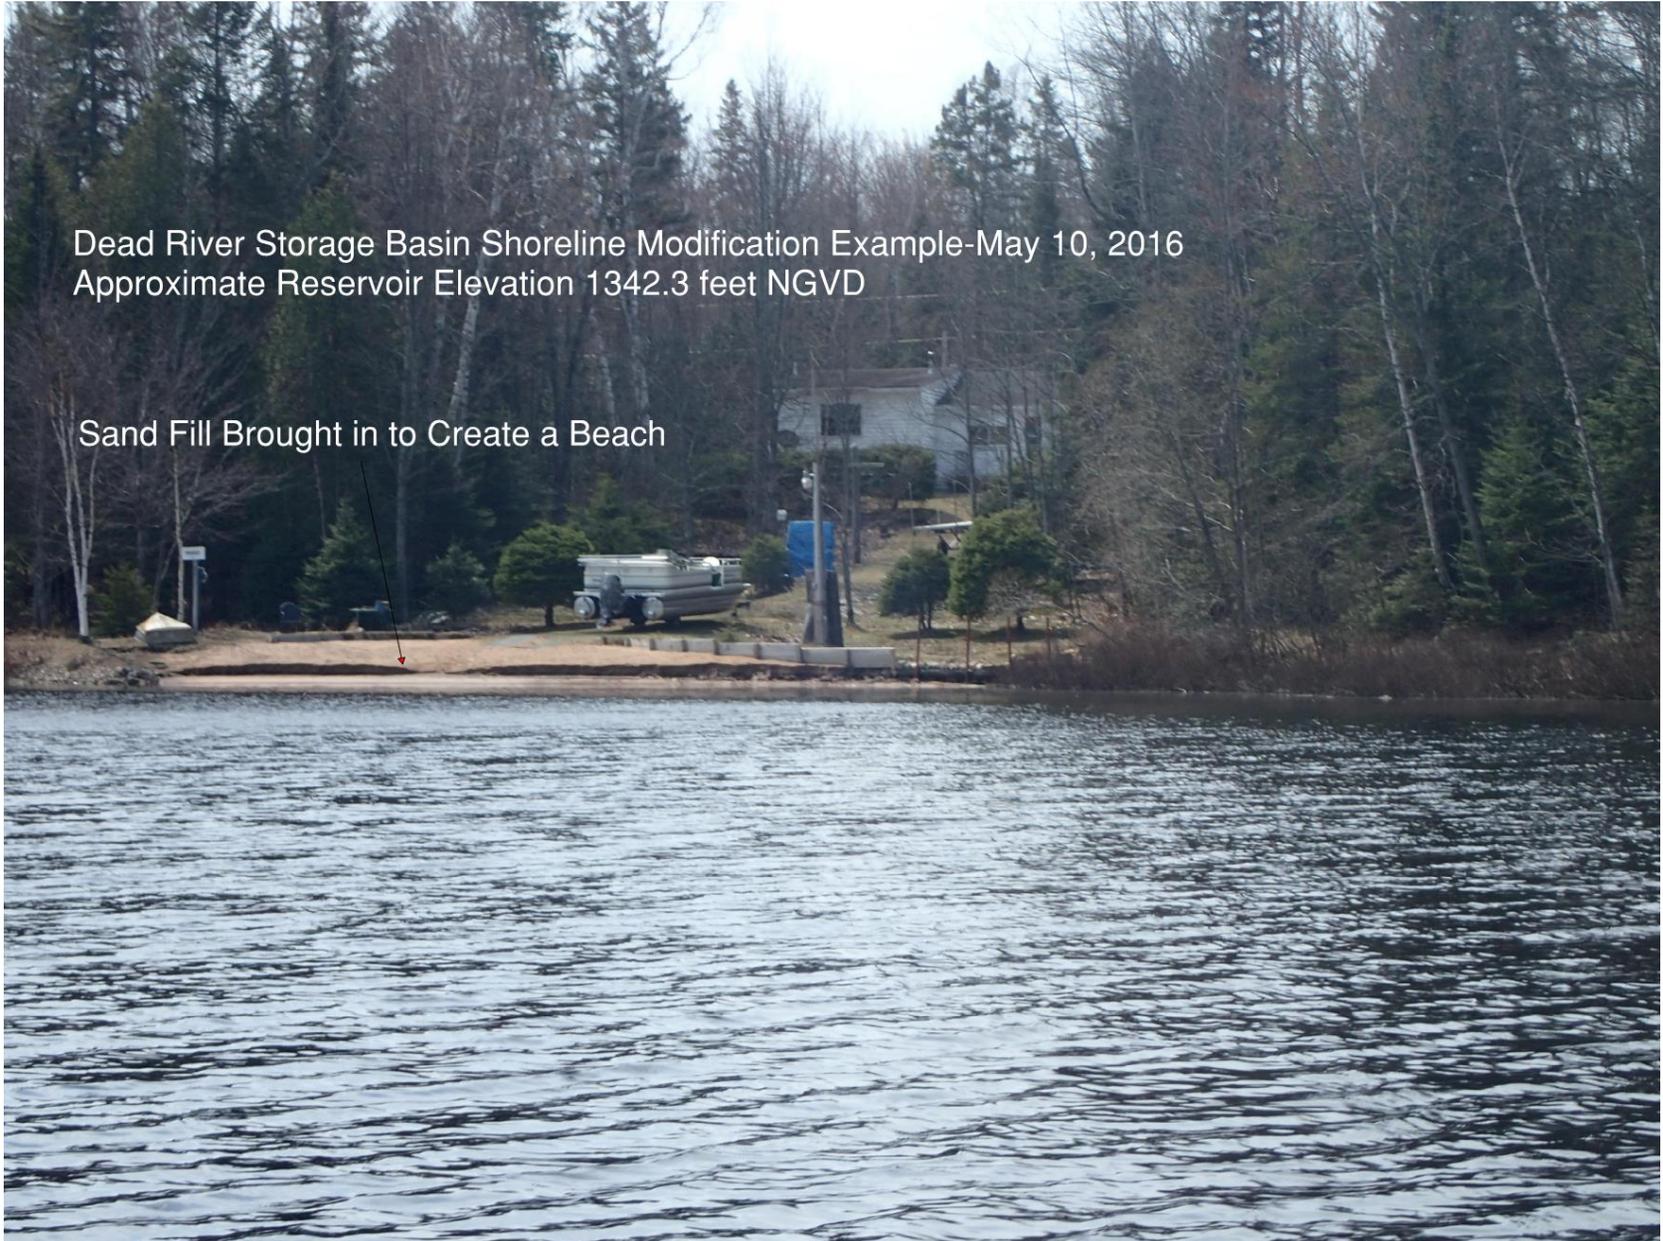
Dead River Storage Basin Shoreline Modification Example-May 10, 2016
Approximate Reservoir Elevation 1342.3 feet NGVD

Sand Fill Brought in to Create a Beach
