Dead River Hydroelectric Project

Follow-Up 2016 Hoist Erosion Survey and 2017 Silver Lake Storage Basin Erosion Survey

APPENDIX A – 2015, 2016 and 2017 Dead River Storage Basin
Photographs

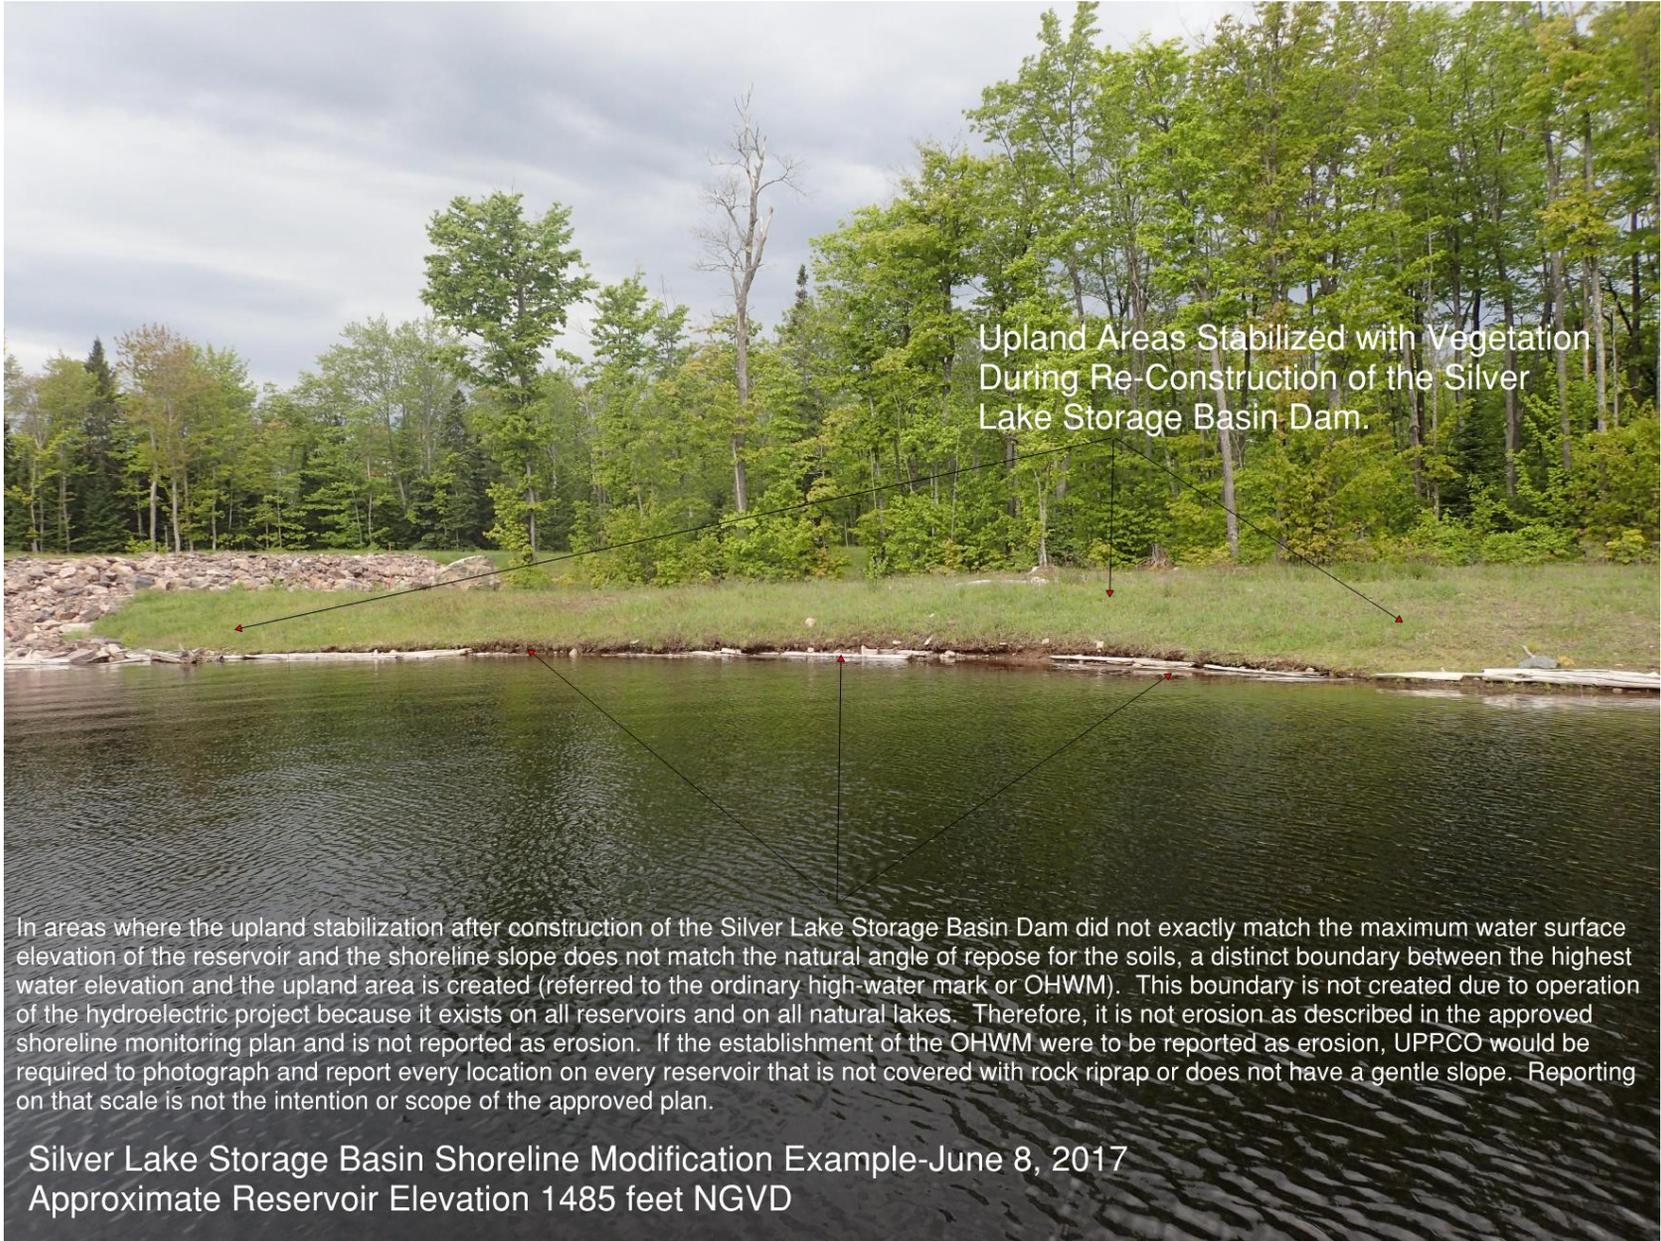
Upland Areas Stabilized with Vegetation During Re-Construction of the Silver Lake Storage Basin Dam.

In areas where the upland stabilization after construction of the Silver Lake Storage Basin Dam did not exactly match the maximum water surface elevation of the reservoir and the shoreline slope does not match the natural angle of repose for the soils, a distinct boundary between the highest water elevation and the upland area is created (referred to the ordinary high-water mark or OHWM). This boundary is not created due to operation of the hydroelectric project because it exists on all reservoirs and on all natural lakes. Therefore, it is not erosion as described in the approved shoreline monitoring plan and is not reported as erosion. If the establishment of the OHWM were to be reported as erosion, UPPCO would be required to photograph and report every location on every reservoir that is not covered with rock riprap or does not have a gentle slope. Reporting on that scale is not the intention or scope of the approved plan.

Silver Lake Storage Basin Shoreline Modification Example-June 8, 2017
Approximate Reservoir Elevation 1485 feet NGVD

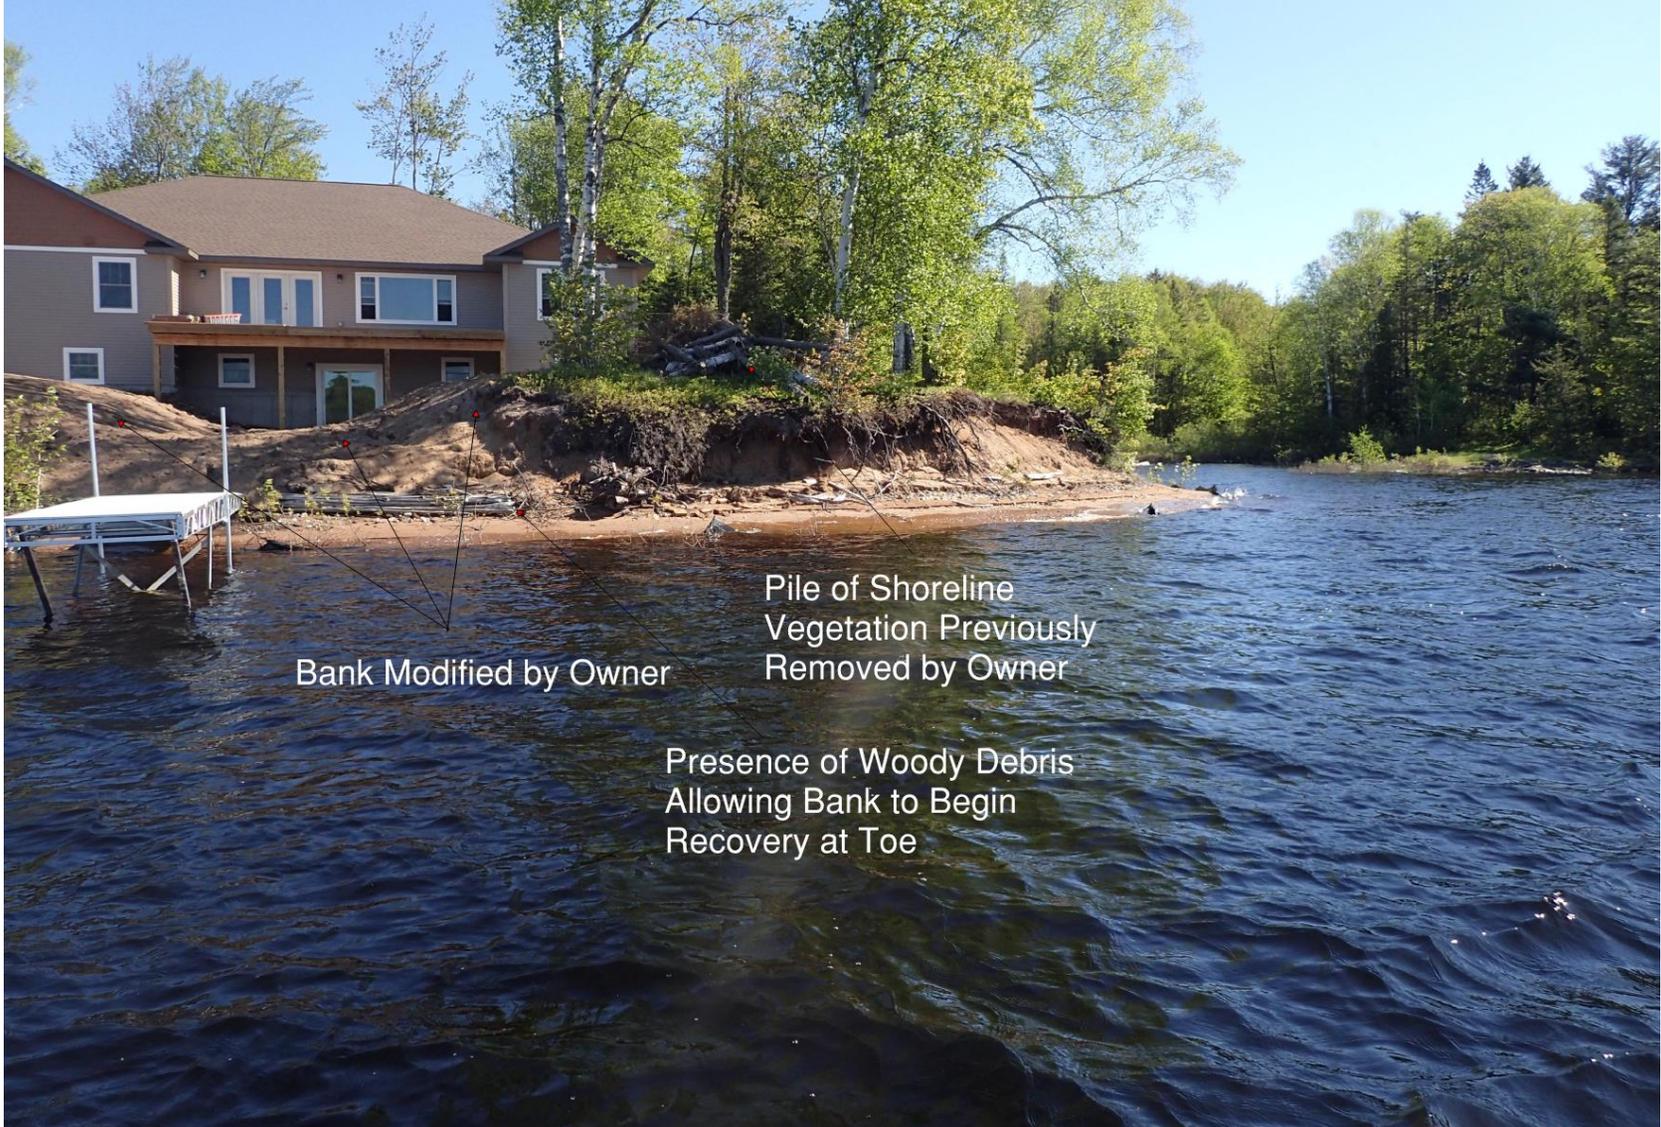
Dead River Storage Basin Shoreline Modification Example - June 7, 2017
Approximate Reservoir elevation 1342.7 Feet NGVD

Bank Modified by Owner

Pile of Shoreline
Vegetation Previously
Removed by Owner

Presence of Woody Debris
Allowing Bank to Begin
Recovery at Toe

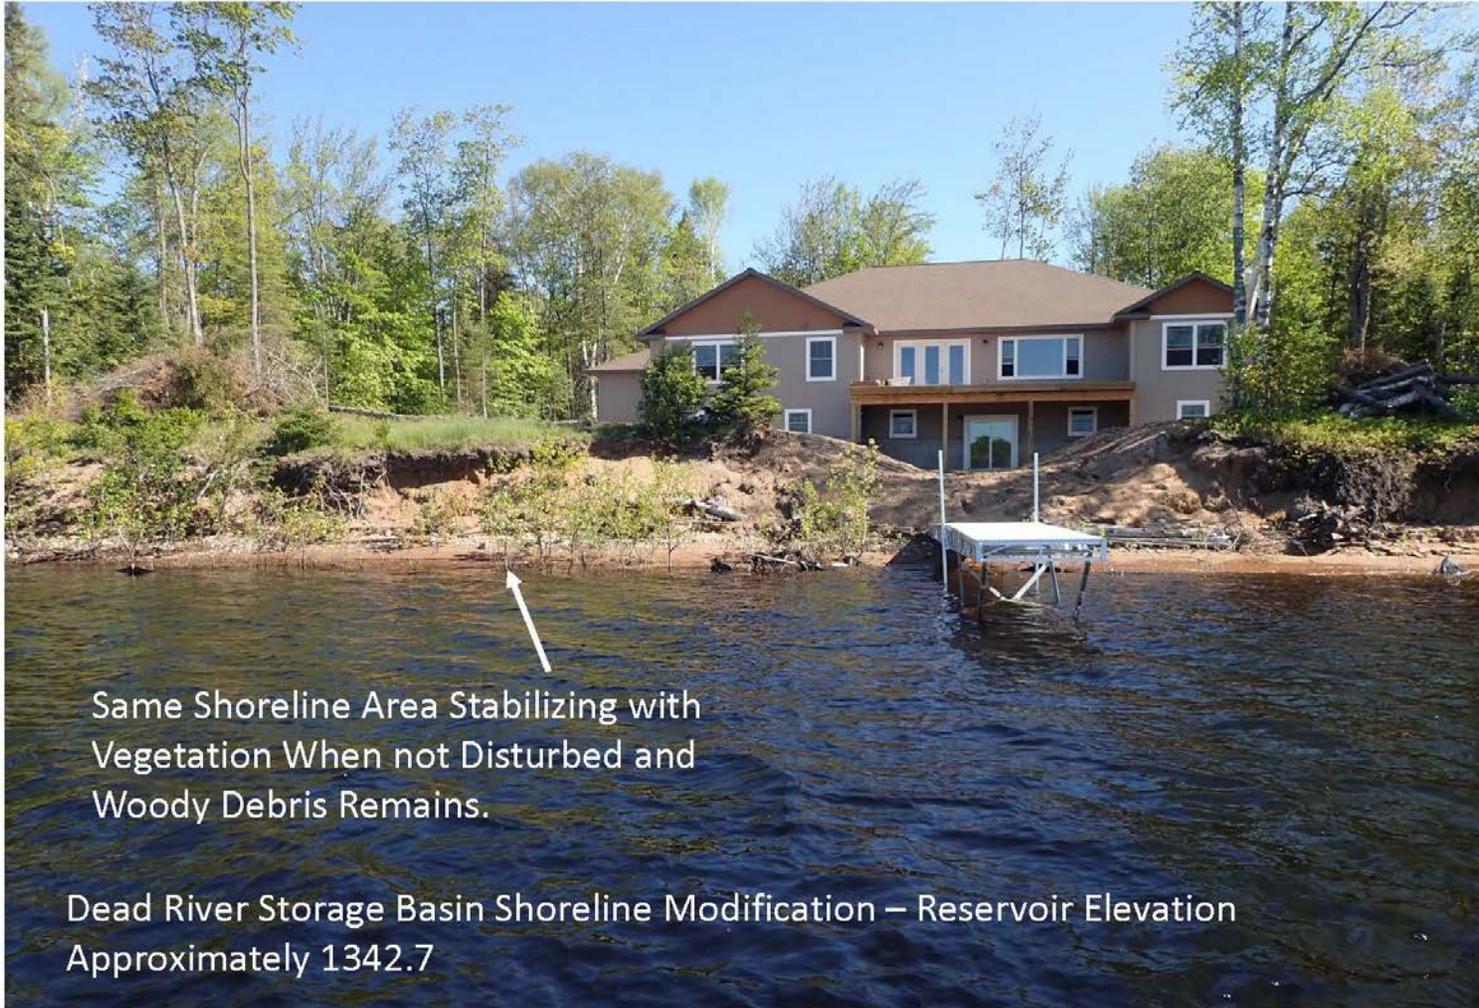
Same Shoreline Area Stabilizing with
Vegetation When not Disturbed and
Woody Debris Remains.

Dead River Storage Basin Shoreline Modification – Reservoir Elevation
Approximately 1342.7
